FINAL REPORT

VOLUME 1

APOLLO SM-LM RCS ENGINE DEVELOPMENT
PROGRAM SUMMARY REPORT

Contract NAS 9-7281

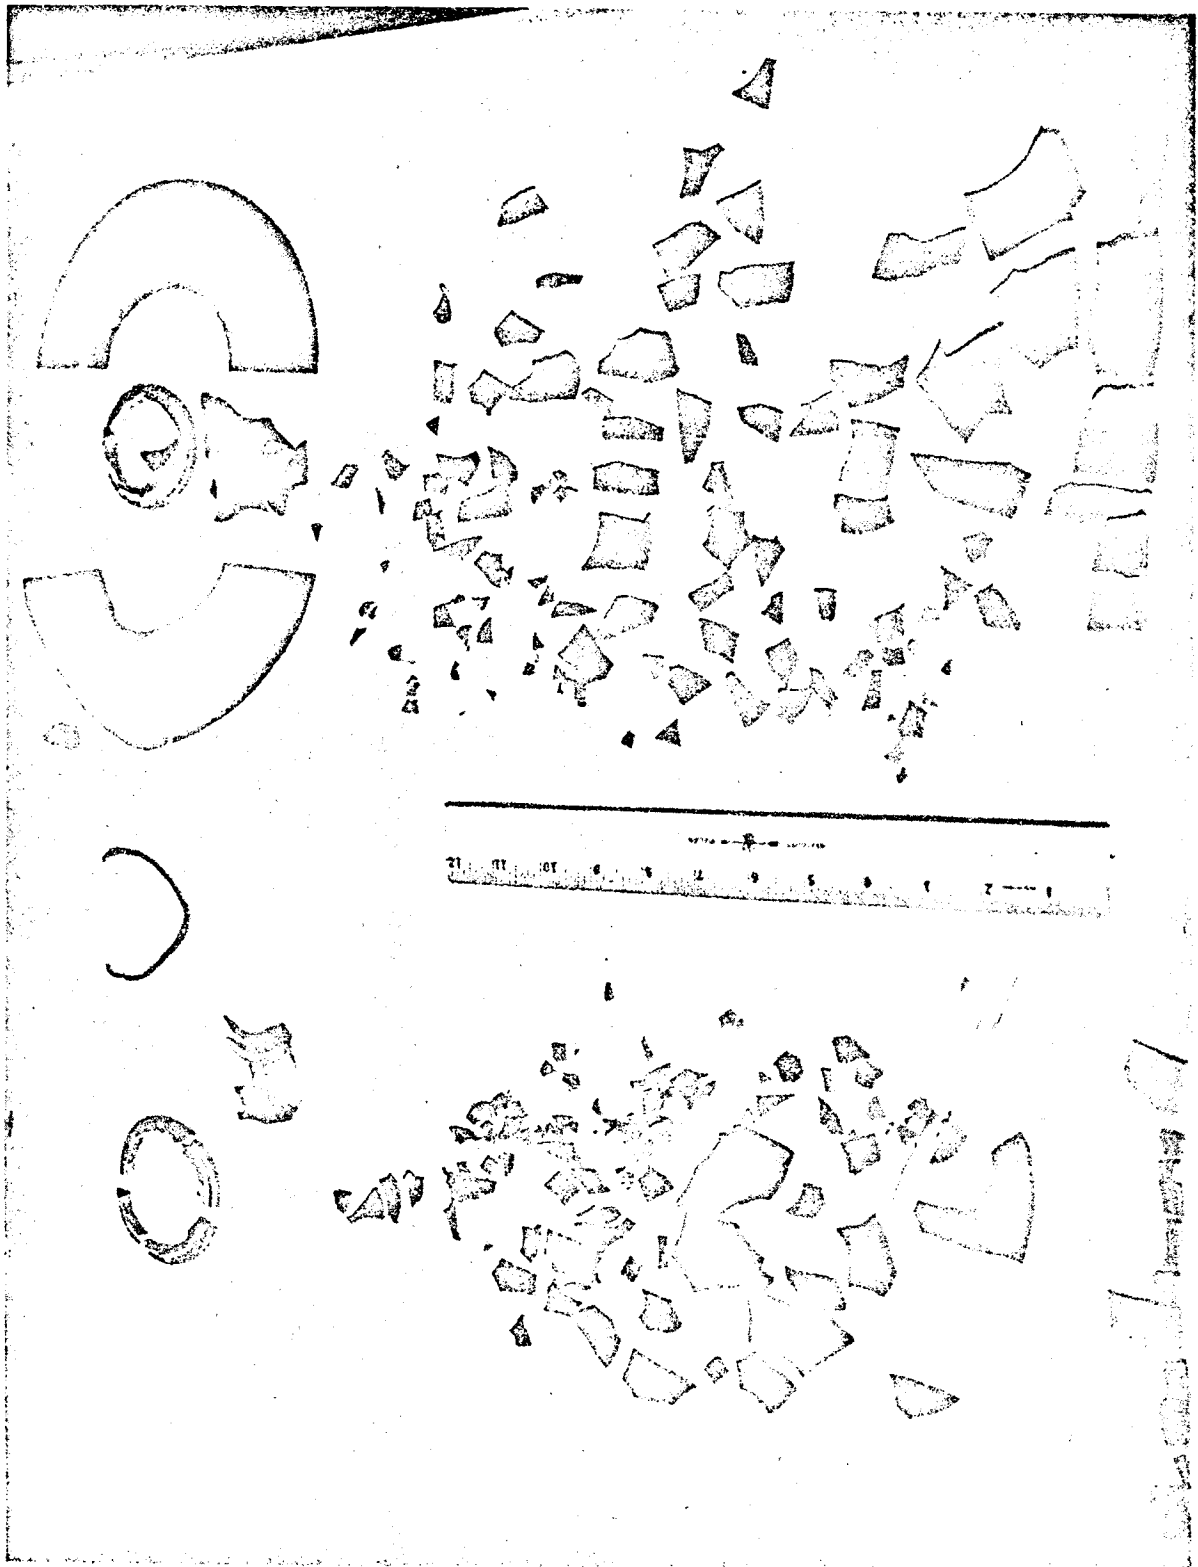
NEG. C9656-2

Fragments of Molybdenum Thrust Chambers

To investigate this possibility, the engine was again rebuilt to the same fuel cooled head configuration except that a stainless steel combustion chamber with a flush mounted pressure pickup for measuring chamber pressure was substituted for the molybdenum combustion chamber. The tests consisted of six 3 second steady state runs and fourteen pulse series (5 pulses each, 10 to 100 ms on, 20 to 200 ms off) for a total run time of 20 seconds with 76 starts. Although the combustion chamber pressure pickup did not have response rates sufficient to pick up the pressure traces to their absolute peak value, the data definitely did show that a severe pressure spike was present at start-up with this large fuel dribble volume injector head configuration. Although the pressure appeared to peak out at around 300 psia on some of these traces, subsequent investigations indicated that the hydrazine vapor ignited explosively and the pressure transducer used was incapable of recording the actual pressures, which probably were at least an order of magnitude higher than recorded. An investigation of recovered portions of the chambers demonstrated that the chambers had failed due to an evenly applied overpressure condition. These data demonstrated a positive correlation between the severe start-up spikes and the length of time between pulses. Figures 15 and 16 show the broken combustors.
